# LYRENACARRIGA WIND FARM

## GEOTECHNICAL ASSESSMENT REPORT

### MKO

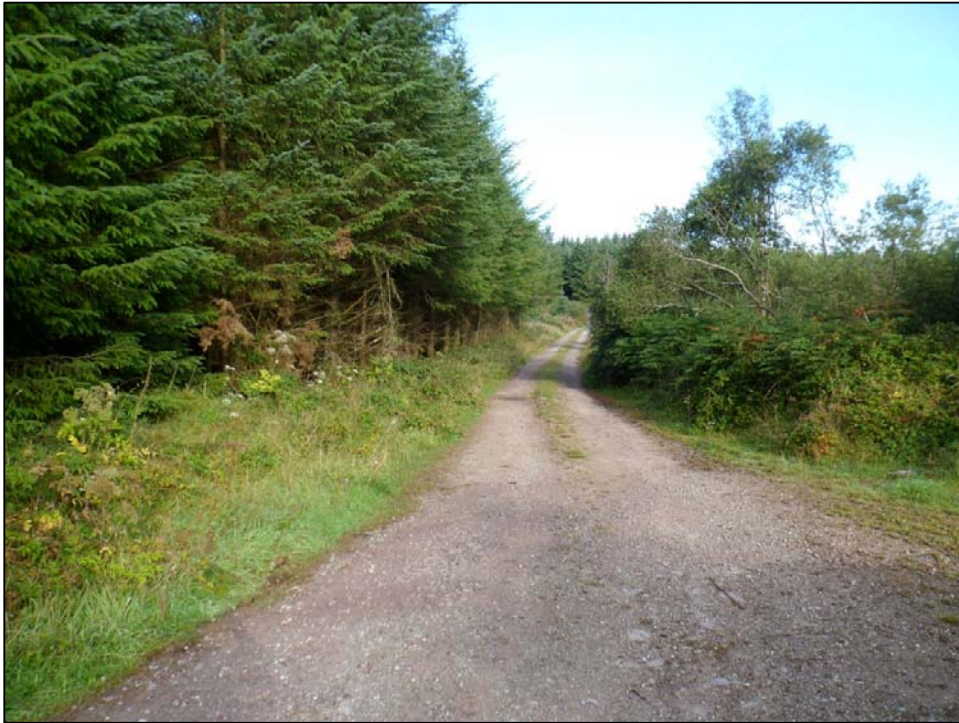
- (8) All existing Coillte access tracks on site have been constructed using a founded i.e. excavate & replace technique (Photos 1 & 2). The access tracks for the wind farm will comprise upgrading of existing founded access tracks and construction of new proposed access tracks using excavate and replace construction techniques.

Photo 1: Example of an existing access track on site

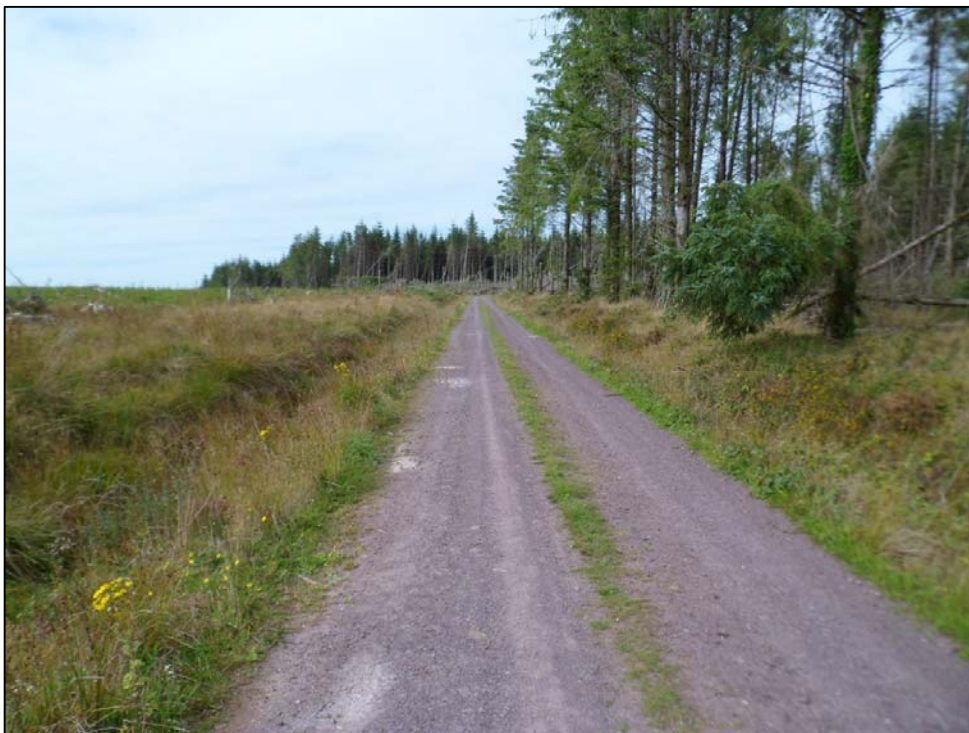
Photo 2: Example of an existing access track on site
