LYRENACARRIGA WIND FARM

GEOTECHNICAL ASSESSMENT REPORT

Prepared for: MKO

Date: December 2020

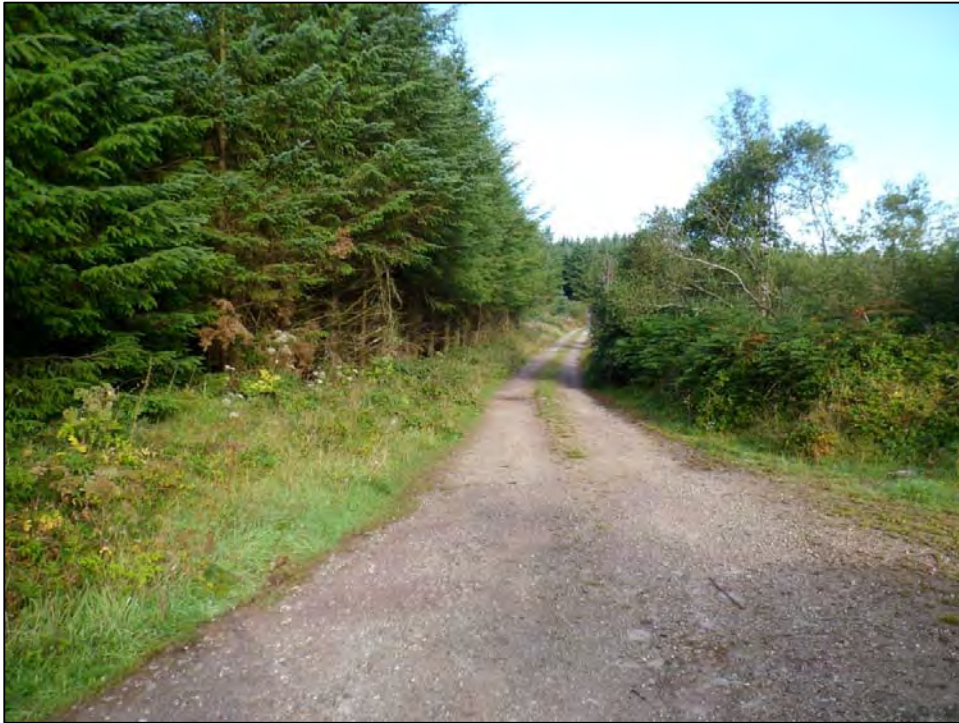
- (8) All existing Coillte access tracks on site have been constructed using a founded i.e. excavate & replace technique (Photos 1 & 2). The access tracks for the wind farm will comprise upgrading of existing founded access tracks and construction of new proposed access tracks using excavate and replace construction techniques.

Photo 1: Example of an existing access track on site

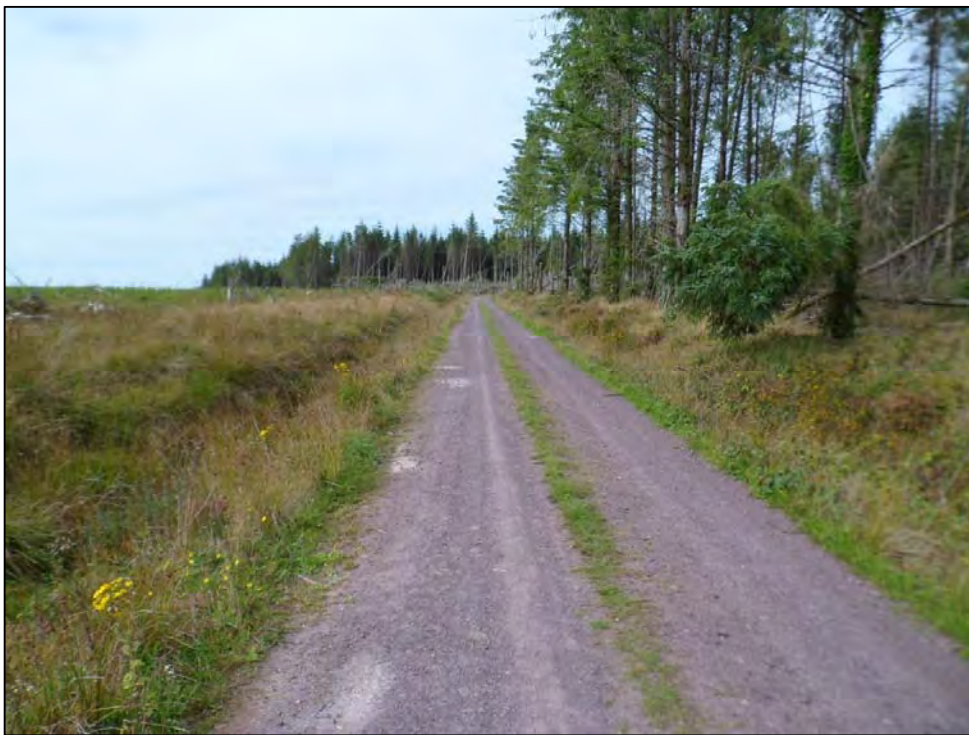
Photo 2: Example of an existing access track on site
