# **Appendix 3 Further Information Response - Ecology**

Lyrenacarriga Windfarm

## **Stream Characterization and Otter Survey**

Lyrenacarriga Wind Farm  
Further Information  
Request

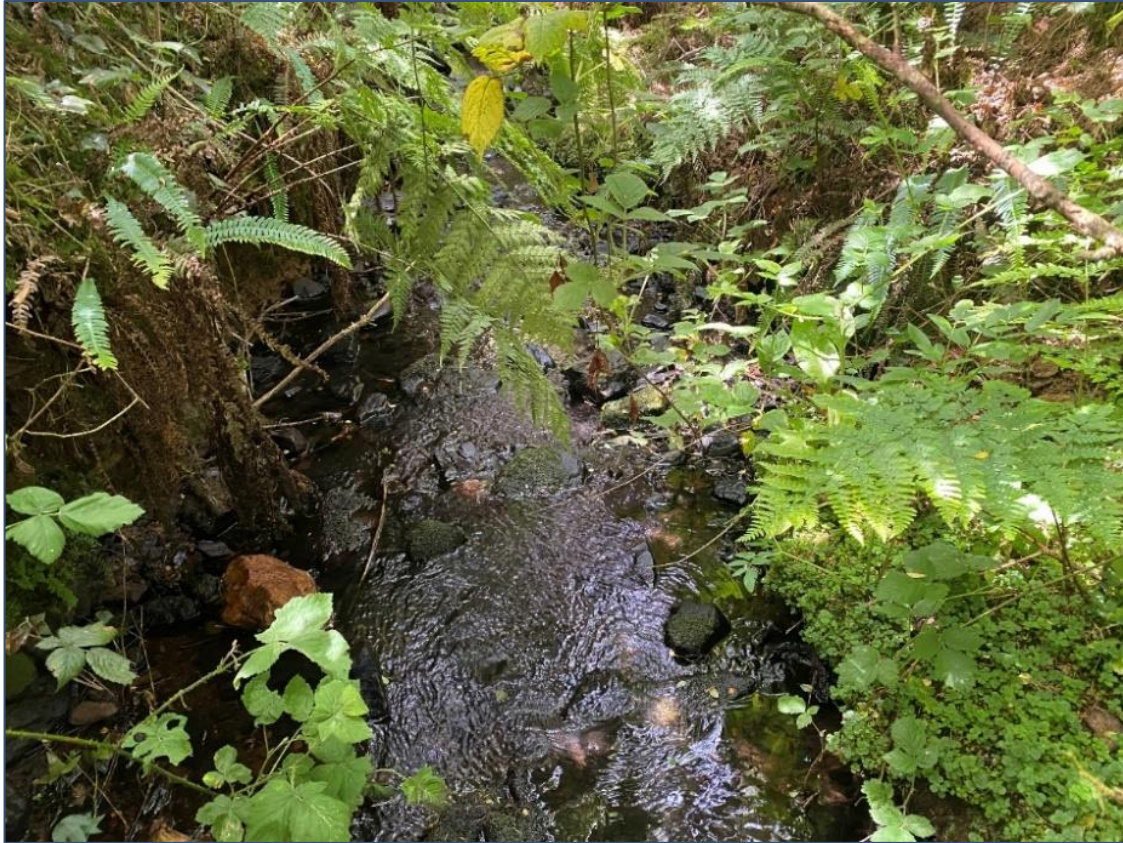
Figure 5-1 Water crossing 1.

Table 5-1 Water crossing 1 Invertebrate Results

Indicator Group	Taxon	Dominance
Group A - Very Pollution Sensitive	None	None
Group B - Moderately Pollution Sensitive	None	None
Group C - Moderately Pollution Tolerant	<i>Gammarus</i>	Present
	<i>Baetis rhodani</i>	Present
	<i>Chironomids</i>	Present
Group D - Very Pollution Tolerant	None	None
Group E - Most Pollution Tolerant	None	None

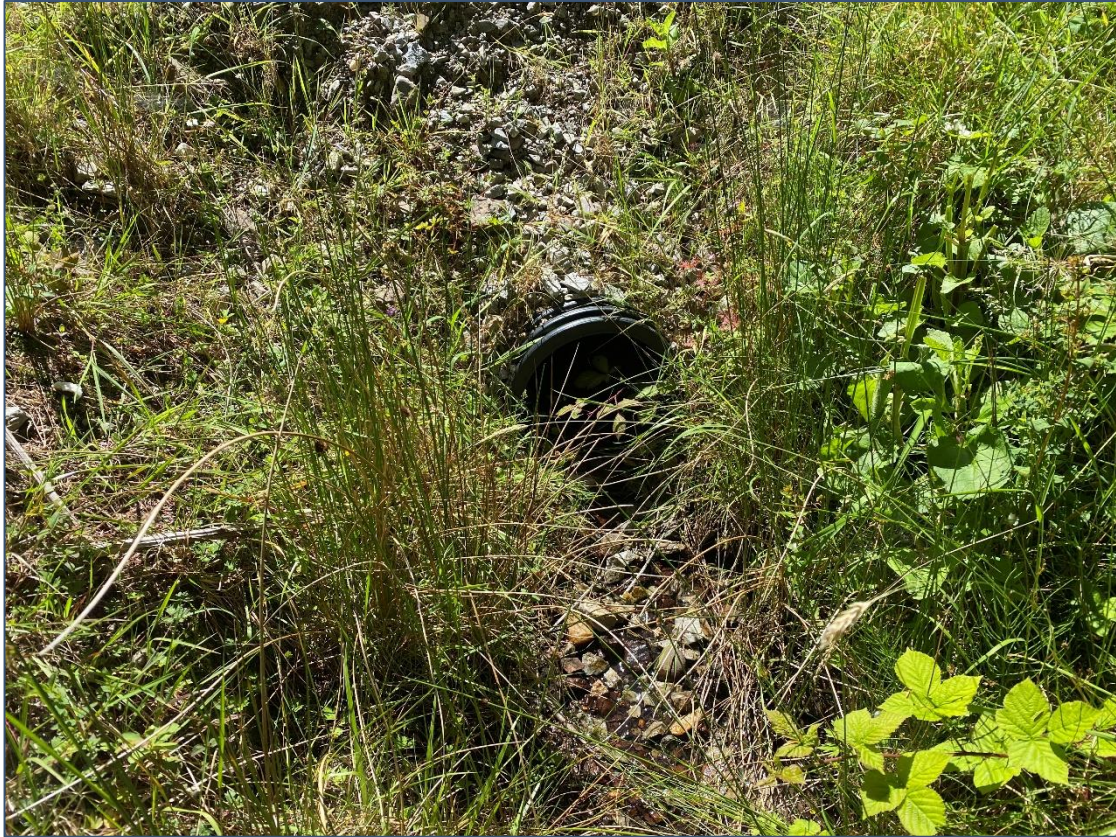
Figure 5-2 Water crossing 2

No submerged or emergent vegetation was recorded within the stream. Bankside vegetation included bramble (*Rubus fruticosus* agg.), rush (*Juncus effusus*), Yorkshire fog (*Holcus lanatus*), and wild angelica (*Angelica sylvestris*). Surrounding land use was predominantly forestry, which caused high shading.

No Q score was assigned at this water crossing as no suitable riffle or glide sections for kick sampling were in the vicinity. The location of the water crossing is ITM 0603329 0587270.

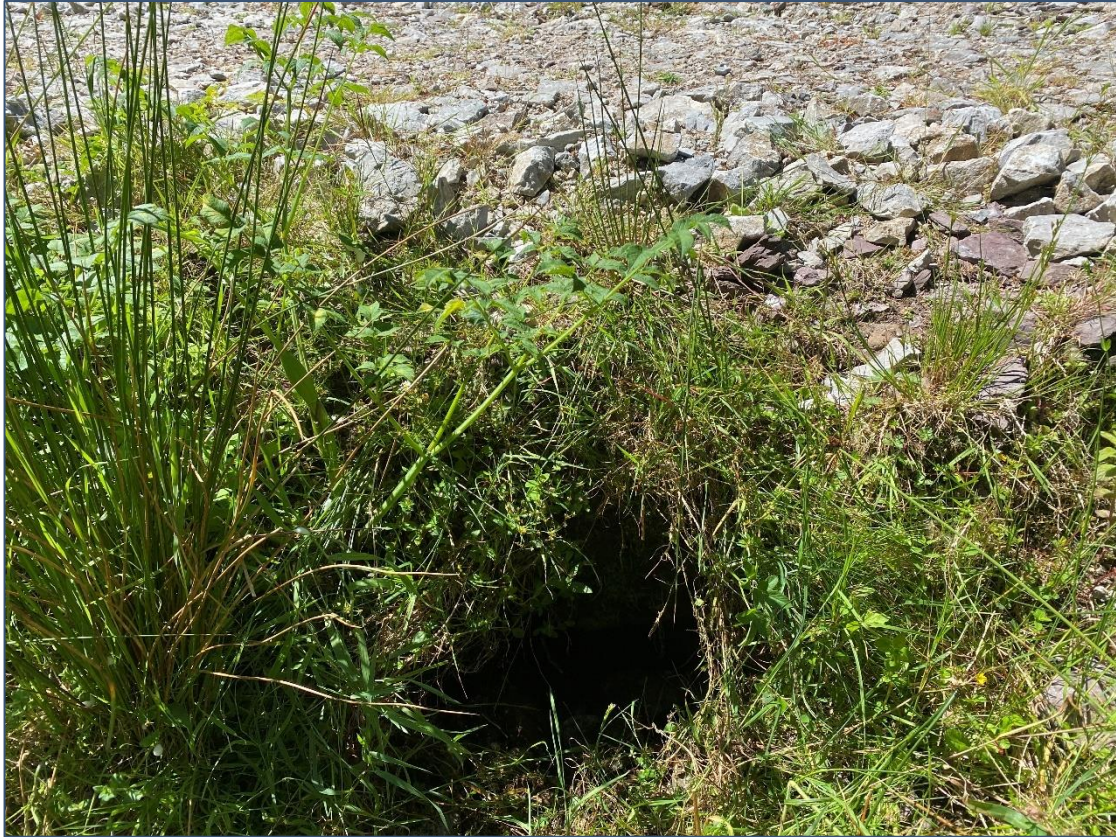
Figure 5-3 Water crossing 3

### 5.2.3 Water crossing 3 – Existing watercourse crossing proposed for upgrade

Located near the western boundary of the eastern section of the proposed development site, this is an existing 300 mm concrete culverted water crossing for a forestry road. This watercourse was dry at the time of survey. This feature was not classified as a watercourse as per Fossitt (2000) as it was dry at the time of the survey and did not support wetland vegetation. Therefore, this watercourse does not provide suitable habitat for otter.

No Q score was assigned at this water crossing as the channel was dry. The location of the water crossing is ITM 0603092 0587126.

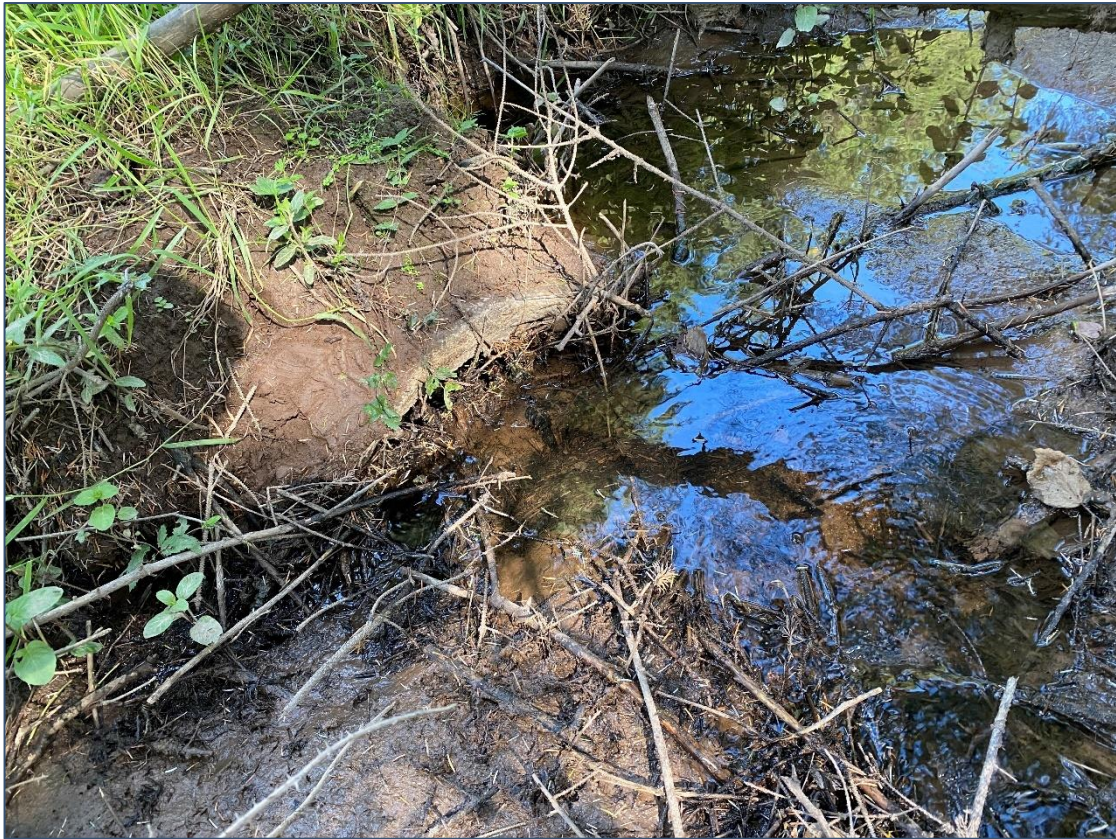
Figure 5-4 Water crossing 4

#### 5.2.4 **Water crossing 4 – Existing watercourse crossing proposed for upgrade**

No instream or emergent vegetation was recorded within this watercourse. Bank vegetation was dominated by forestry, which created high shading.

No Q score was assigned at this water crossing as no suitable riffle or glide sections for kick sampling were in the vicinity. The location of the water crossing is ITM 0603329 0587270.

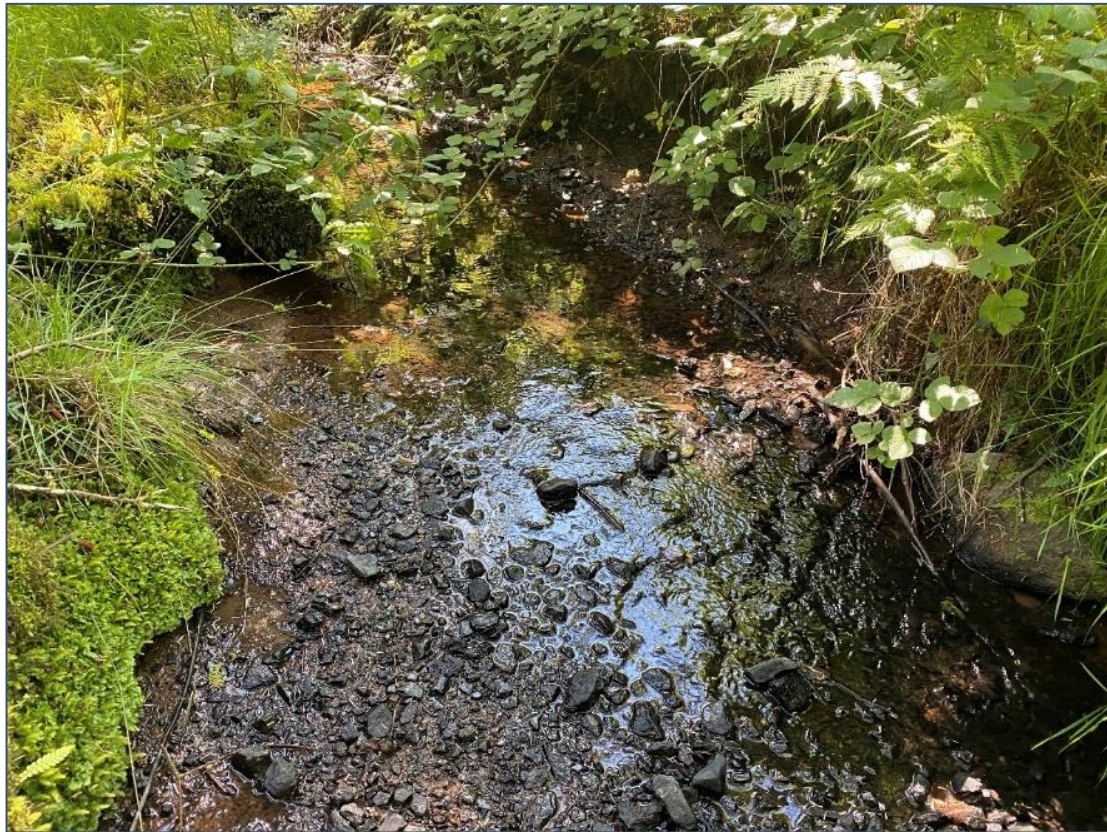
Figure 5-5 Water crossing 5

## 5.2.5 Water crossing 5 – Existing watercourse crossing proposed for upgrade

No submerged or emergent vegetation was recorded within the stream. Bankside vegetation included ivy (*Hedera helix*), wild angelica (*Angelica sylvatica*), bramble (*Rubus fruticosus* agg.), ferns and bryophytes. Surrounding land use was predominantly forestry, which caused high shading.

Indicator Group	Taxon	Dominance
Group A - Very Pollution Sensitive	None	None
Group B - Moderately Pollution Sensitive	None	None

Indicator Group	Taxon	Dominance
Group C - Moderately Pollution Tolerant	<i>Gammarus</i>	<i>Dominant</i>
Group D - Very Pollution Tolerant	<i>Chironimidae</i>	<i>Present</i>
Group E - Most Pollution Tolerant	<i>Tubificidae</i>	<i>Present</i>

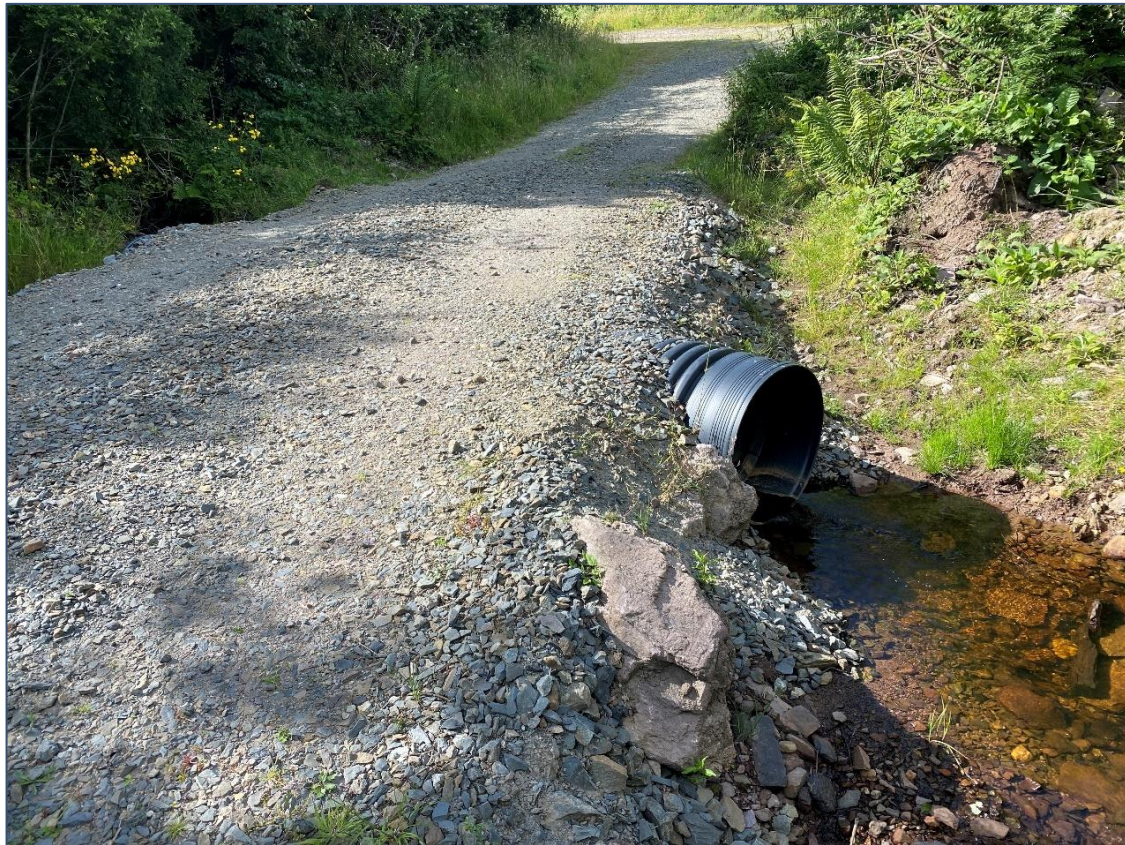
Figure 5-6 Water crossing 6

## 5.2.6 Water crossing 6 – Existing watercourse crossing proposed for upgrade

Located in the centre of the eastern section of the proposed development site, this is an existing 500 mm plastic culverted water crossing of the Ballynatray Commons stream which discharges to the Glendine stream to the east, for a forestry road. The invert of the culvert was not embedded in the substrate, so flow continuity was broken. The kick sample was taken downstream of the culvert. Here, the stream was 1m wide with an average depth of 40 mm. This watercourse was classified as an upland/eroding stream (FW1). Though the watercourse provides suitable commuting habitat for otter, no indication of otter using this watercourse were recorded.

No submerged or emergent vegetation was recorded within the stream. Bankside vegetation included ivy (*Hedera helix*), wild angelica (*Angelica sylvestris*), cocks' foot (*Dactylis glomerata*), ragwort (*Jacobaea aquatica*), and willow (*Salix* sp.). Surrounding land use was predominantly forestry, which caused high shading.

Table 5-3 Water crossing 6 Invertebrate Results

Indicator Group	Taxon	Dominance
Group A - Very Pollution Sensitive	<i>None</i>	<i>None</i>
Group B - Moderately Pollution Sensitive	<i>None</i>	<i>None</i>
Group C - Moderately Pollution Tolerant	<i>Gammarus</i>	<i>Dominant</i>
	<i>Baetis rhodeni</i>	<i>Common</i>
Group D - Very Pollution Tolerant	<i>Flatworms</i>	<i>Common</i>
Group E - Most Pollution Tolerant	<i>None</i>	<i>None</i>

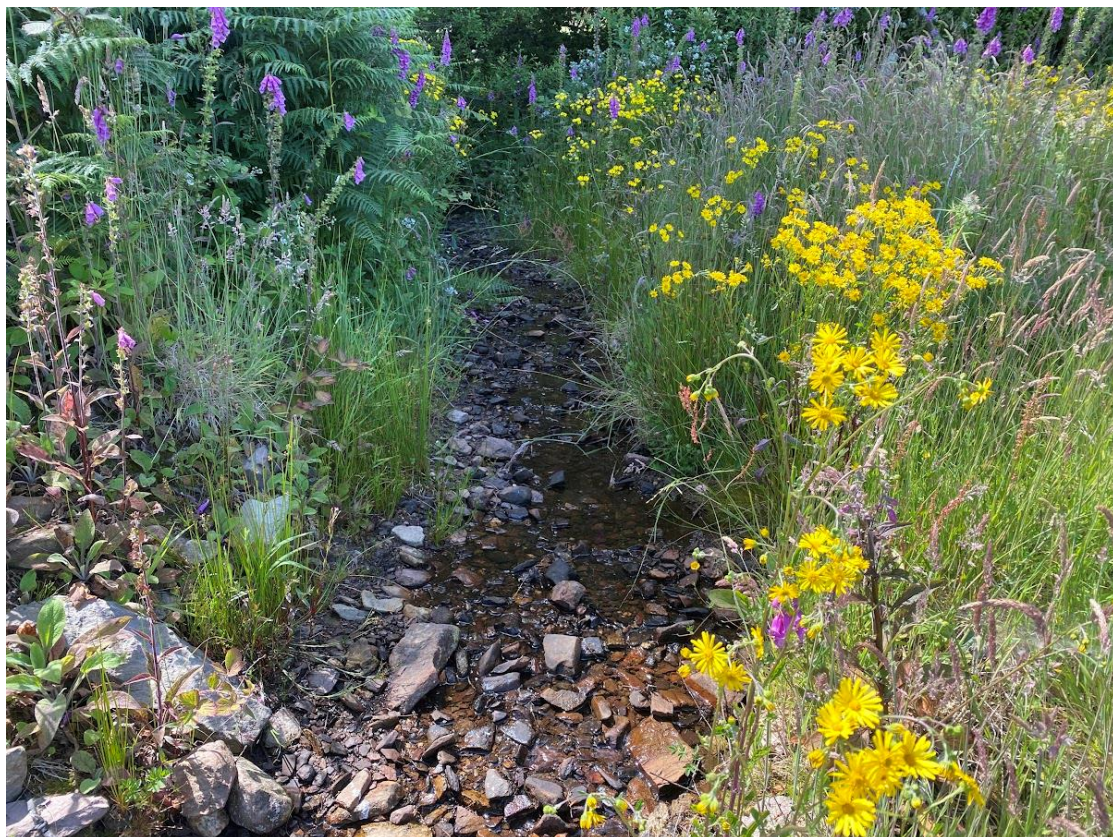
Figure 5-7 Water crossing 7

## 5.2.7 Water crossing 7 – Proposed Watercourse Crossing

No submerged or emergent vegetation was recorded within the stream. Bankside vegetation included bracken (*Pteridium aquilinum*), wild angelica (*Angelica sylvestris*), bramble (*Rubus fruticosus* agg.), fox glove (*Digitalis purpurea*), marsh ragwort (*Jacobaea aquatica*), Yorkshire fog (*Holcus lanatus*), and hard rush (*Juncus inflexus*). Surrounding land use was predominantly forestry, which caused high shading, and tillage.

Table 5-4 Water crossing 7 Invertebrate Results

Indicator Group	Taxon	Dominance
Group A - Very Pollution Sensitive	<i>Heptageniidae</i>	<i>Few</i>
Group B - Moderately Pollution Sensitive	<i>None</i>	<i>None</i>
Group C - Moderately Pollution Tolerant	<i>Gammarus</i>	<i>Dominant</i>
	<i>Baetis rhodeni</i>	<i>Few</i>
	<i>Uncased Caddis</i>	<i>Few</i>
Group D - Very Pollution Tolerant	<i>Flatworms</i>	<i>Few</i>
Group E - Most Pollution Tolerant	<i>None</i>	<i>None</i>

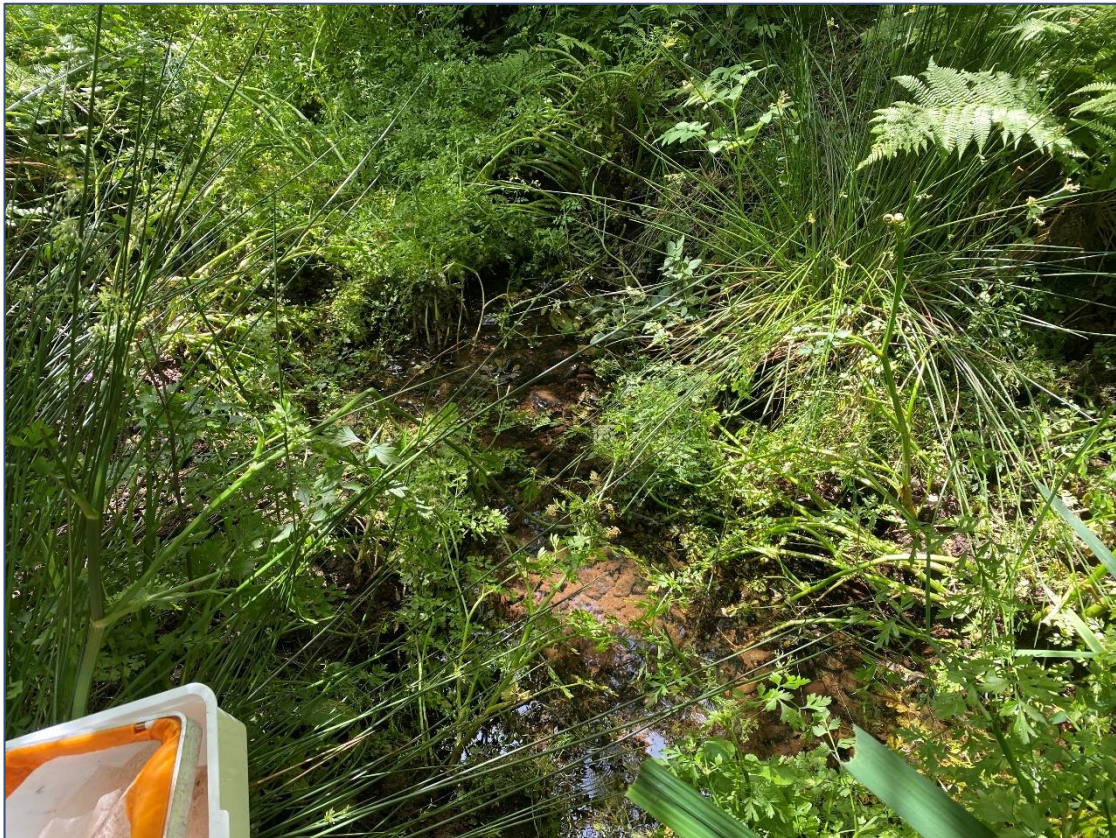
Figure 5-8 Water crossing 8

## 5.2.8 Water crossing 8 – Proposed Watercourse Crossing

No submerged vegetation was recorded within the stream, but hemlock water dropwort (*Oenanthe crocata*) was recorded as emergent. Bank vegetation included fox glove (*Digitalis purpurea*), hemlock water dropwort (*Oenanthe crocata*), soft rush (*Juncus effusus*), and wild angelica (*Angelica sylvestris*). Surrounding land use was conifer forestry but willow (*Salix* sp.) dominated the stream bank, causing high shading.

No Q score was assigned at this water crossing as there was no suitable riffles or glides to kick sample from. The location of the water crossing is ITM 0604324 0586728.

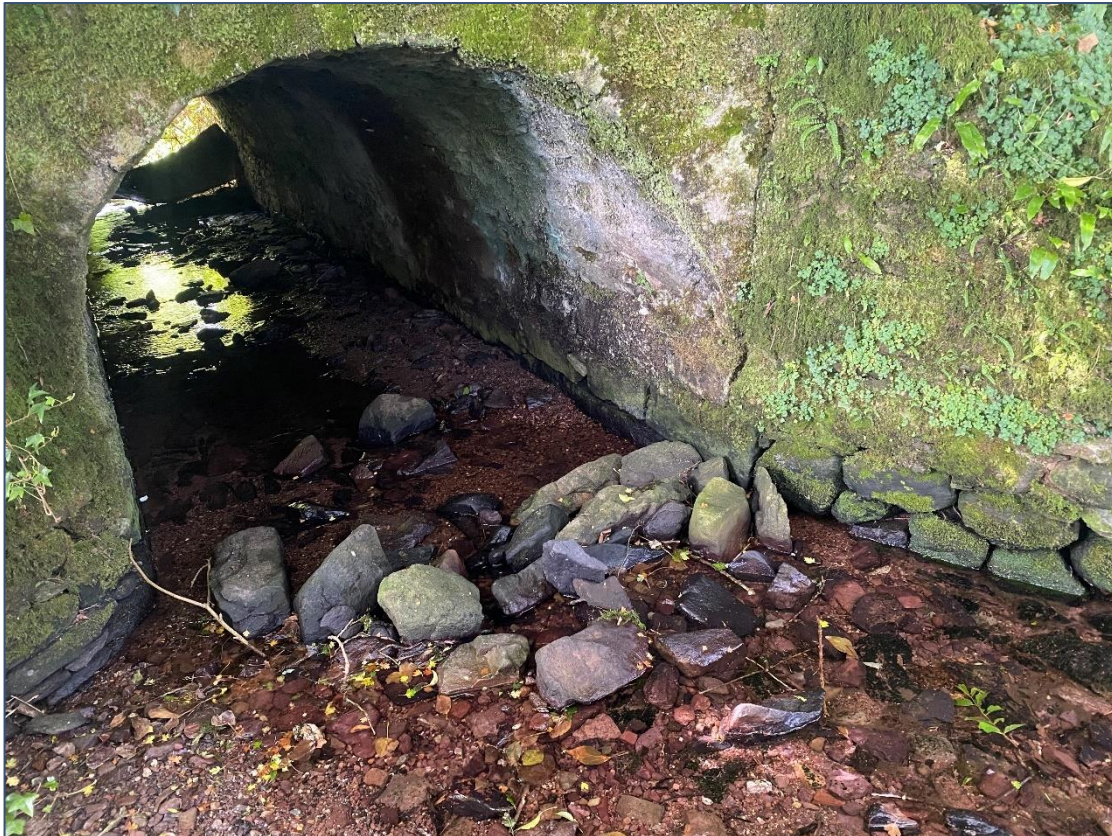
Figure 5-9 water crossing 9

## 5.2.9 Water crossing 9 - Existing watercourse crossing proposed for upgrade

Table 5-5 Water crossing 9 Invertebrate Results

Indicator Group	Taxon	Dominance
Group A - Very Pollution Sensitive	<i>Heptageniidae</i>	<i>present</i>
Group B - Moderately Pollution Sensitive	<i>Leuctra</i>	<i>Few</i>
	<i>Goeridae</i>	<i>Numerous</i>
Group C - Moderately Pollution Tolerant	<i>Gammarus</i>	<i>Numerous</i>
	<i>Baetis rhodeni</i>	<i>Common</i>
	<i>Uncased Caddis</i>	<i>Few</i>
Group D - Very Pollution Tolerant	<i>Ancylus</i>	<i>Present</i>
	<i>Chironomids</i>	<i>Few</i>
Group E - Most Pollution Tolerant	<i>None</i>	<i>None</i>

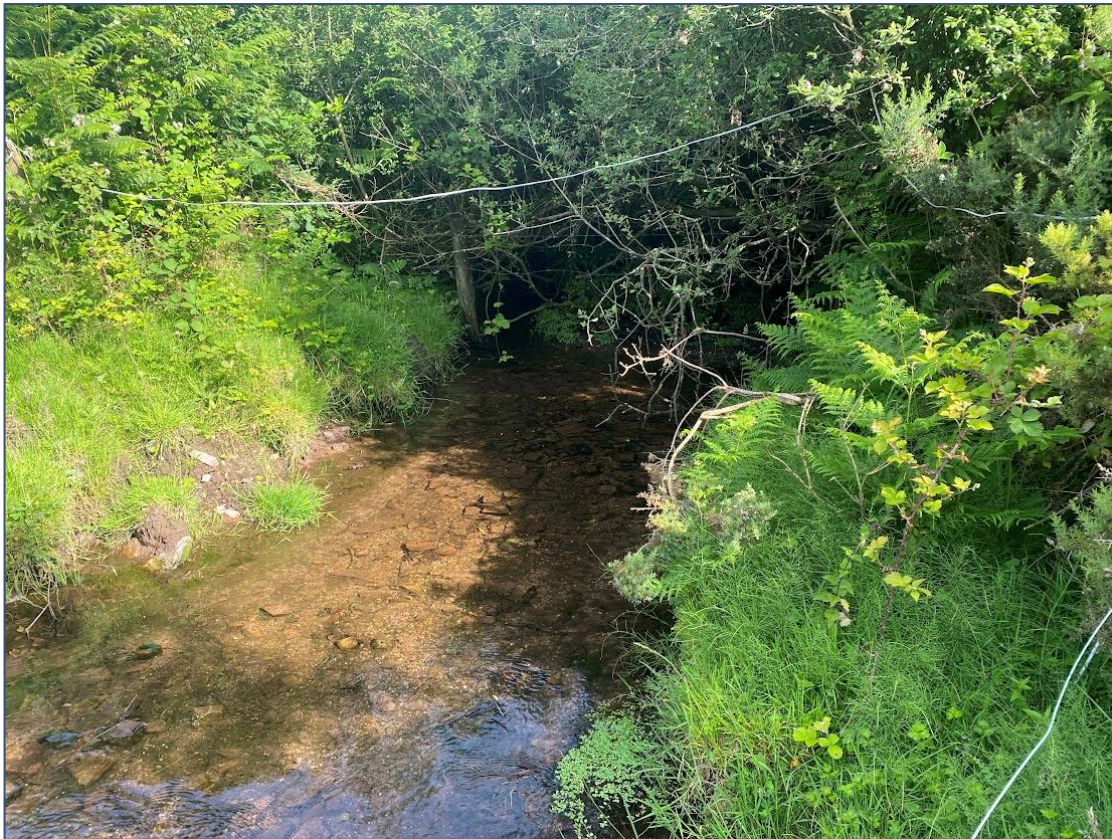
Figure 5-10 Water crossing 10

## 5.2.10 Water crossing 10 – Proposed Watercourse Crossing

Indicator Group	Taxon	Dominance
Group A - Very Pollution Sensitive	<i>Heptageniidae</i>	<i>Common</i>
Group B - Moderately Pollution Sensitive	<i>Goeridae</i>	<i>Numerous</i>
Group C - Moderately Pollution Tolerant	<i>Gammarus</i>	<i>Common</i>
	<i>Baetis rhodeni</i>	<i>Common</i>

Indicator Group	Taxon	Dominance
	<i>Ephemerelellidae</i>	<i>Few</i>
	<i>Coleoptera</i>	<i>Present</i>
Group D - Very Pollution Tolerant	<i>Chironomids</i>	<i>Common</i>
Group E - Most Pollution Tolerant	<i>None</i>	<i>None</i>

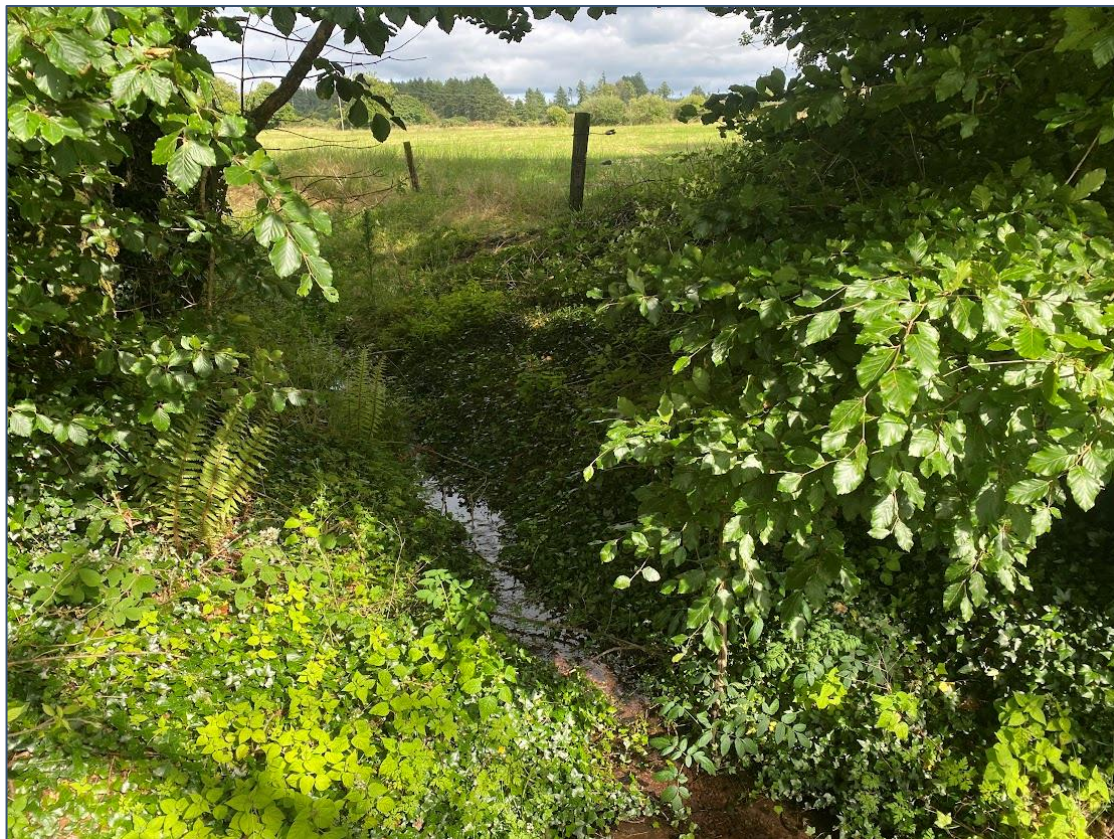
Figure 5-11 water crossing 11

### 5.2.11 Water crossing 11 - Existing watercourse crossing proposed for upgrade

Table 5-6 Water crossing 11 Invertebrate Results

Indicator Group	Taxon	Dominance
Group A - Very Pollution Sensitive	<i>Heptageniidae</i>	<i>Few</i>
Group B - Moderately Pollution Sensitive	<i>Goeridae</i>	<i>Numerous</i>
Group C - Moderately Pollution Tolerant	<i>Gammarus</i>	<i>Common</i>
	<i>Baetis rhodeni</i>	<i>Few</i>
	<i>Uncased Caddis</i>	<i>Few</i>
Group D - Very Pollution Tolerant	<i>Flatworms</i>	<i>Common</i>
	<i>Chironomids</i>	<i>Few</i>
Group E - Most Pollution Tolerant	<i>None</i>	<i>None</i>

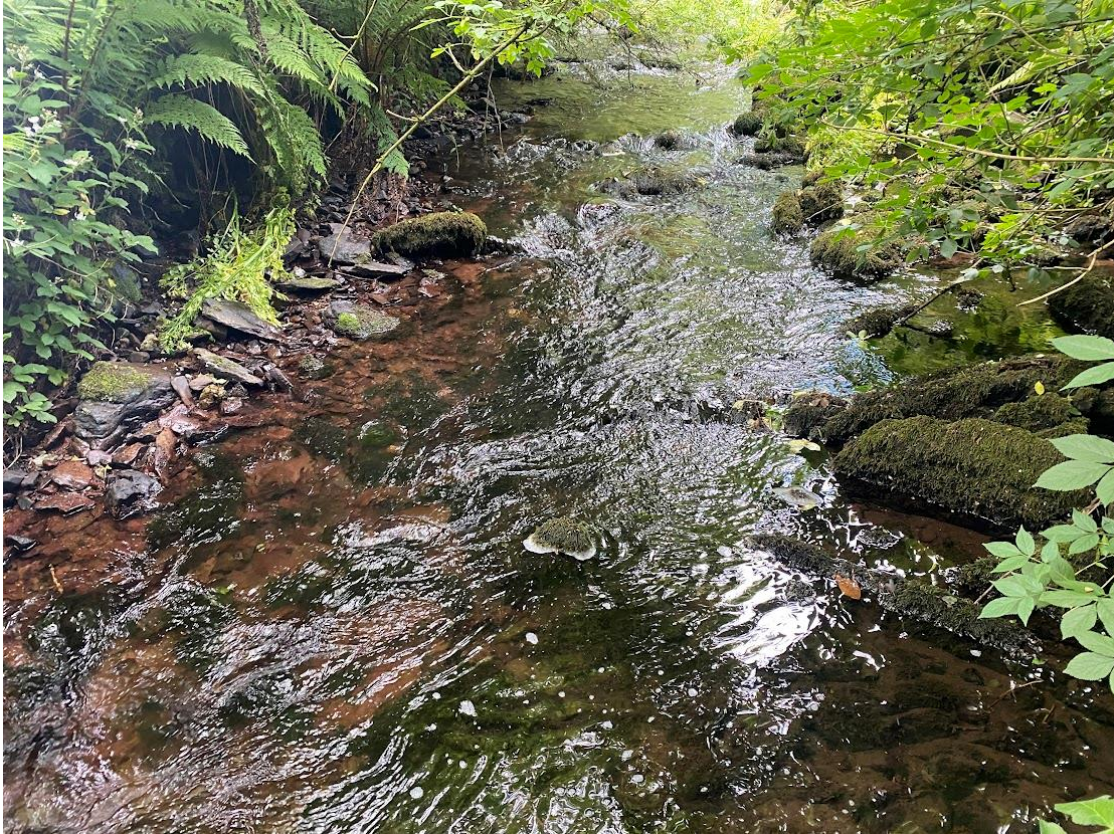
Figure 5-12 Water crossing 13

Table 5-7 Water crossing 13 Invertebrate Results

Indicator Group	Taxon	Dominance
Group A - Very Pollution Sensitive	<i>Heptageniidae</i>	<i>Common</i>
Group B - Moderately Pollution Sensitive	<i>Goeridae</i>	<i>Numerous</i>
Group C - Moderately Pollution Tolerant	<i>Gammarus</i>	<i>Common</i>
	<i>Baetis rhodeni</i>	<i>Common</i>
	<i>Uncased Caddis</i>	<i>Few</i>
	<i>Ephemeralla</i>	<i>Few</i>
Group D - Very Pollution Tolerant	<i>Chironomids</i>	<i>Common</i>
Group E - Most Pollution Tolerant	<i>None</i>	<i>None</i>
