Aquatic Macroinvertebrate Sampling Report

Lyrenacarriga Wind Farm

Document Title: **Aquatic Macroinvertebrate Sampling Report**

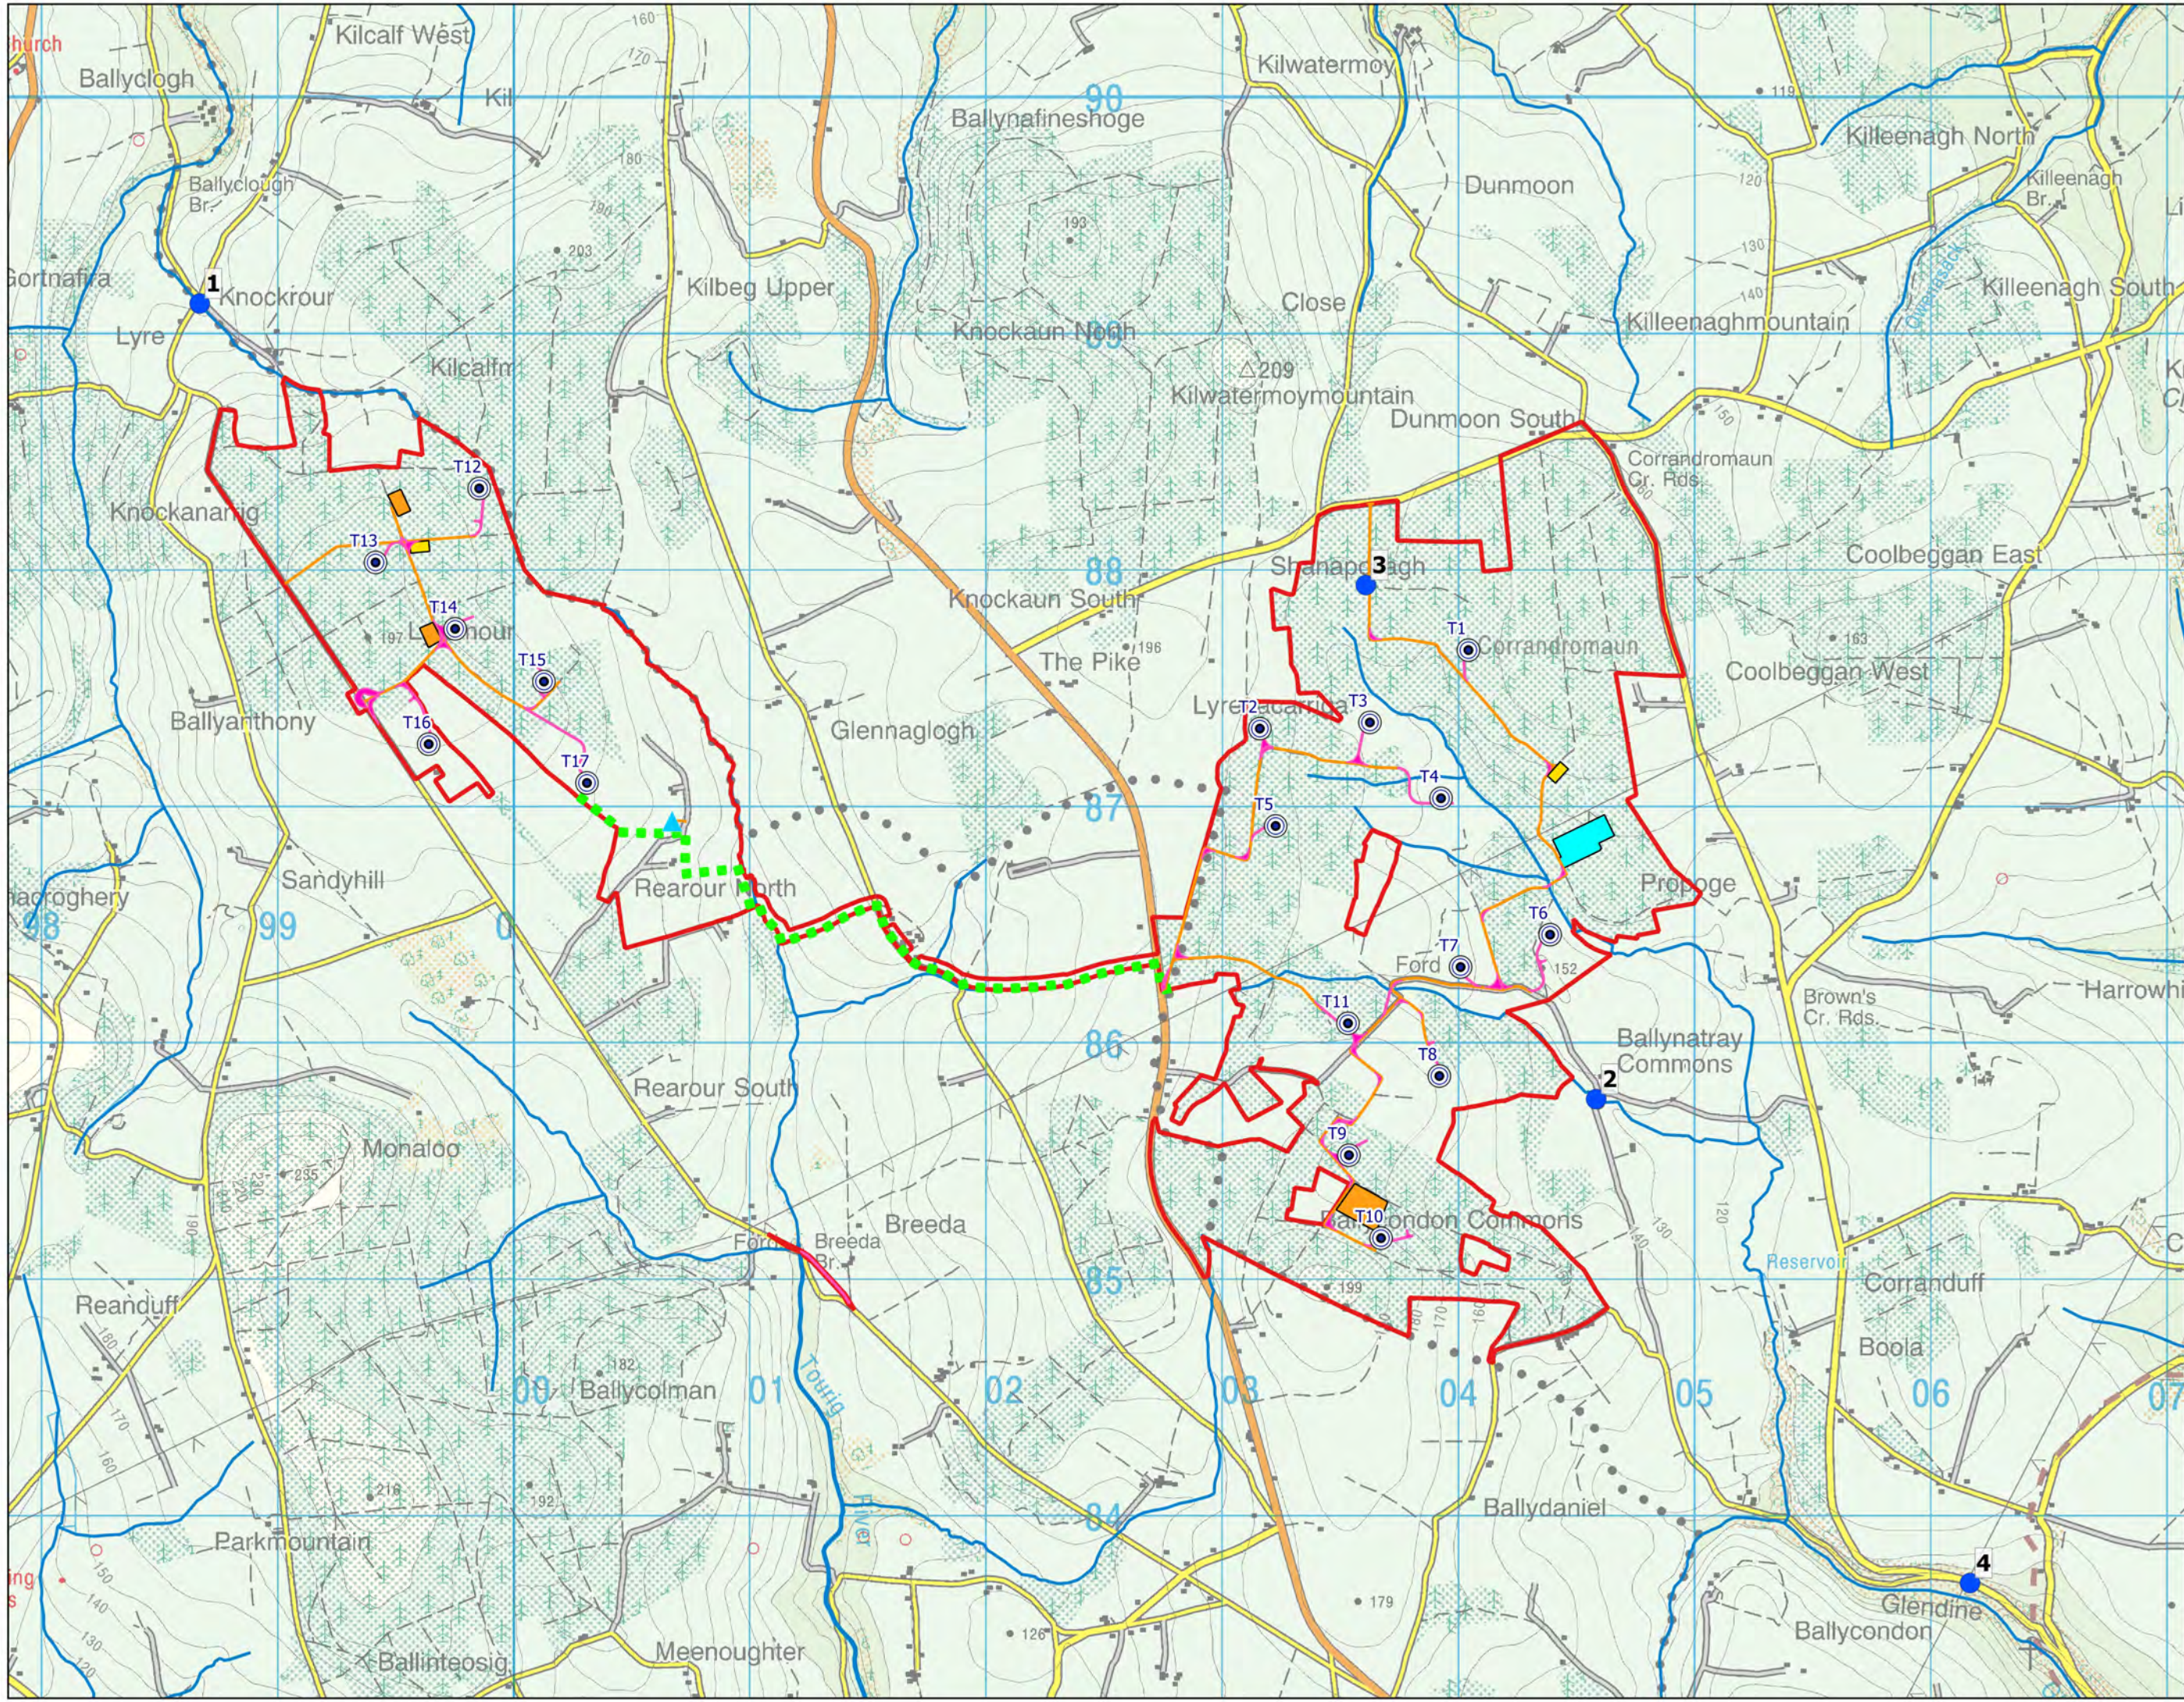
Drawn By H Witter	Checked By D McNicholas
Project No. 170749	Drawing No. Figure 1-1
Scale 1:25000	Date 2020.11.06

Kick Sample Locations

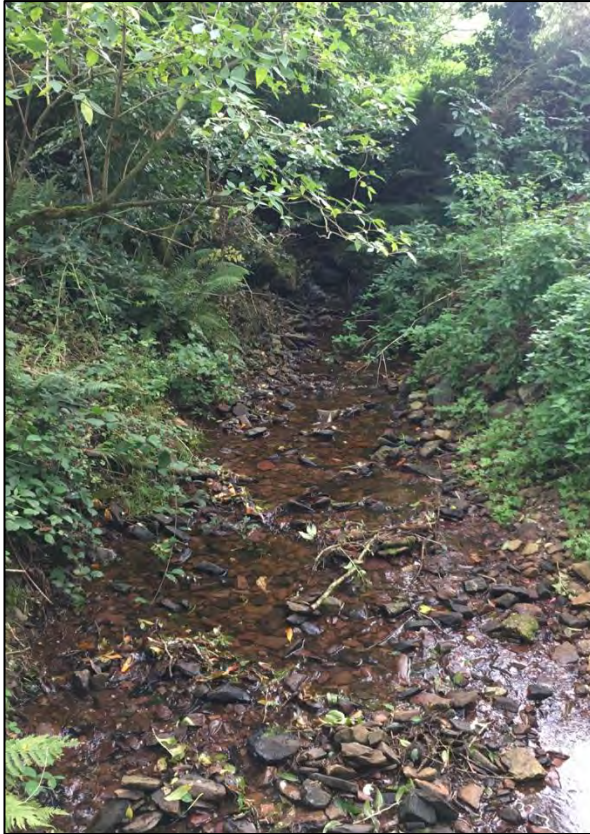
Sample Station 1 is located to the west of the site at the Knockour Crossroads (grid ref.: W 98673 89174). Flow was of a moderate velocity and was slightly turbid. The main land use upstream of the sample site is pasture and forestry. Trees species recorded included Ash (*Fraxinus excelsior*), beech (*Fagus sylvatica*) and elder (*Sambucus nigra*). Bankside vegetation included Ivy (*Hedera helix*), Bracken (*Pteridium aquilinum*), nettles (*Urtica dioica*), Himalayan Balsam (*Impatiens glandulifera*), Herb Robert (*Geranium robertianum*), hogweed (*Heracleum sphondylium*), and elder (*Sambucus nigra*). The substrate comprised cobble, gravel and fine gravel. Emergent macrophytes recorded included creeping buttercup (*Ranunculus repens*).

The Q rating assigned to the channel was Q3. It was assigned this value as Group A invertebrates were absent, Group B invertebrates were scarce, Group C invertebrates were excessive, Group D was absent and Group E had scarce representatives.

Plate 2-1 Sample Station 1 at Knockrour Crossroads (grid ref: W 98673 89174) – Q3

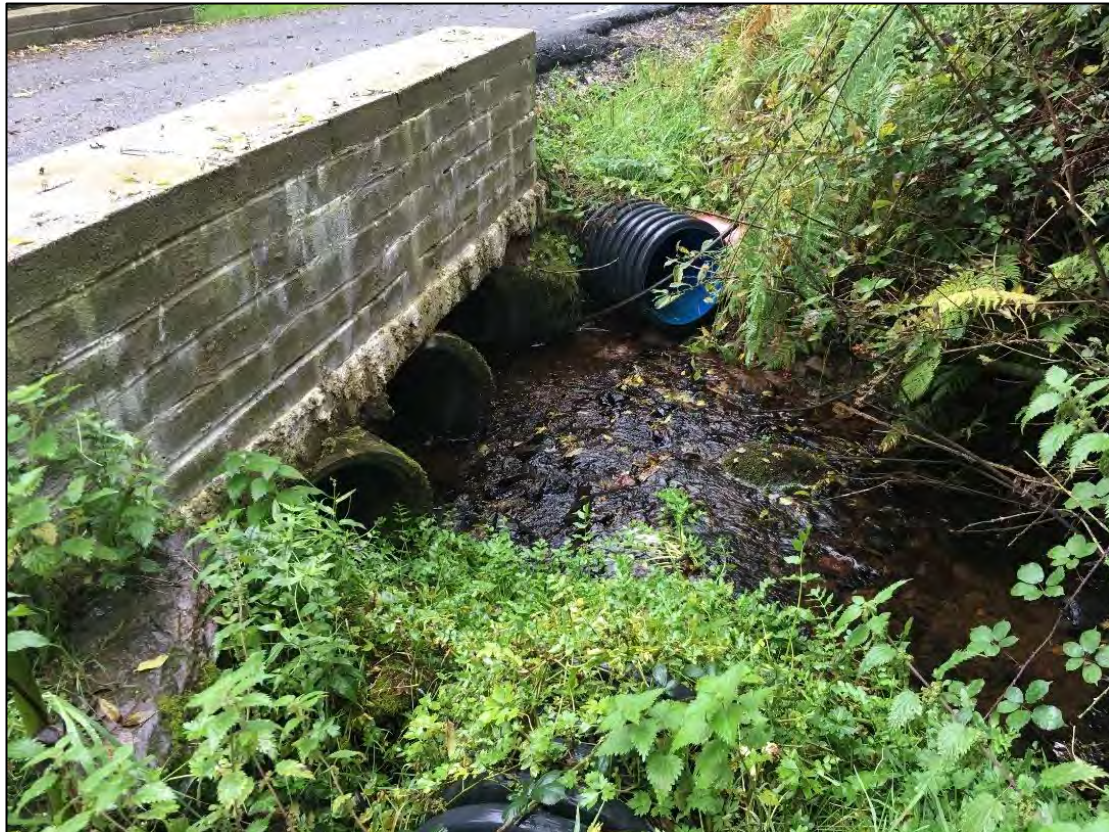
Sample Station 2 is located within the eastern parcel, just west of Ballynatray Commons (grid ref: X 04596 85793). Tree species recorded included willows (*Salix spp.*), ash (*Fraxinus excelsior*) and hawthorn (*Crataegus monogyna*) along with ivy (*Hedera helix*). Bankside vegetation included Bramble (*Rubus fruticosus agg.*), Ivy (*Hedera helix*), nettles (*Urtica dioica*), willows (*Salix spp.*) and ash (*Fraxinus excelsior*). The river was fast flowing and slightly turbid. The substrate comprised cobble, gravel, fine gravel and silt. Instream macrophytes included fool’s watercress (*Apium nodiflorum*) and emergent macrophytes included nettles (*Urtica dioica*). Upstream land use consisted of pasture.

The Q rating assigned to the channel was Q3-4, as group A was present in small numbers, Group B was common, group C was numerous, Group D was absent and group E was scarce.

Plate 2-2 Sample Station 2 (grid ref: X 04596 85793) – Q3-4

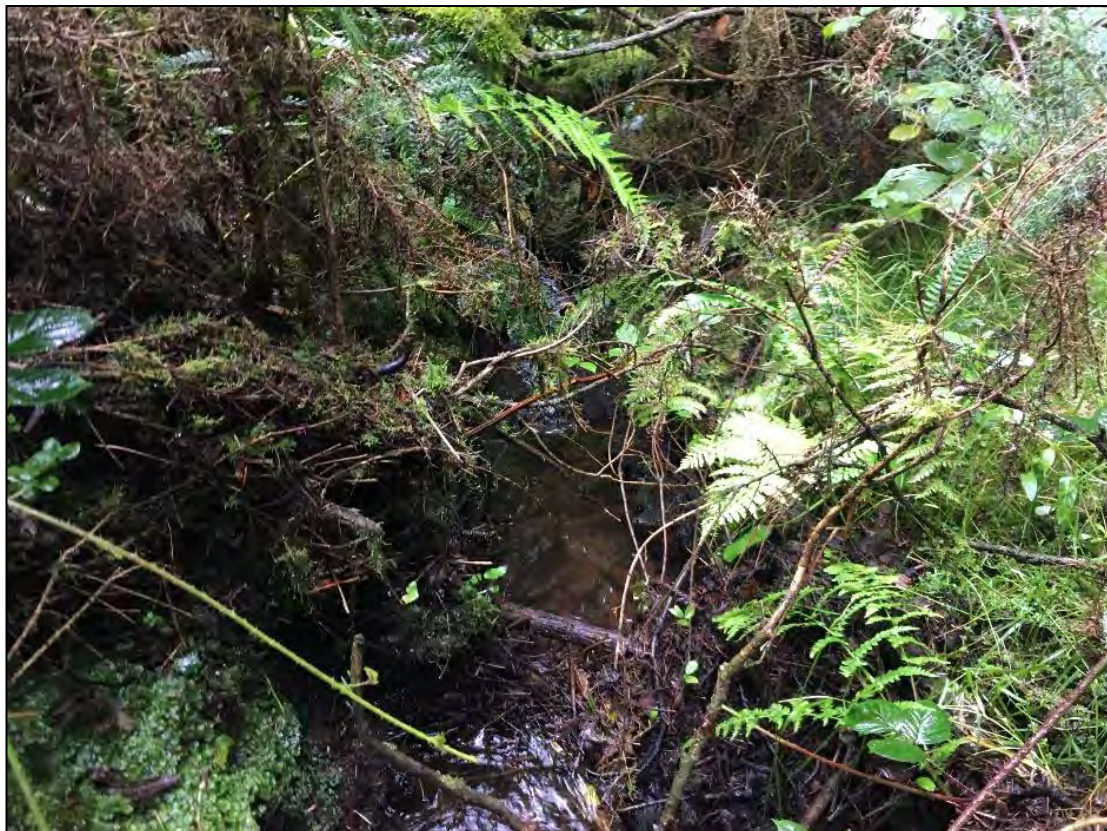
Sample Station 3 is located in the eastern parcel to the north (grid ref: X 03628 87911). Tree species recorded included Sitka Spruce (*Picea sitchensis*) and willows (*Salix spp.*). Bankside vegetation included Bramble (*Rubus fruticosus agg.*), gorse (*Ulex europaeus*), willows (*Salix spp.*), ferns and Bracken (*Pteridium aquilinum*). The river was fast flowing and slightly turbid. The substrate comprised bedrock, fine gravel and silt. No instream vegetation was recorded but emergent vegetation included hair moss (*Polytrichum spp.*) and liverworts. Upstream land use consisted of conifer plantation.

The Q rating assigned to the channel was Q3. It was assigned this value as Group A and B invertebrates were absent, Group C invertebrates were common, Group D was absent and Group E had one representative.

Plate 2-3 Sample Station 3 (grid ref: X 03628 87911) - Q3

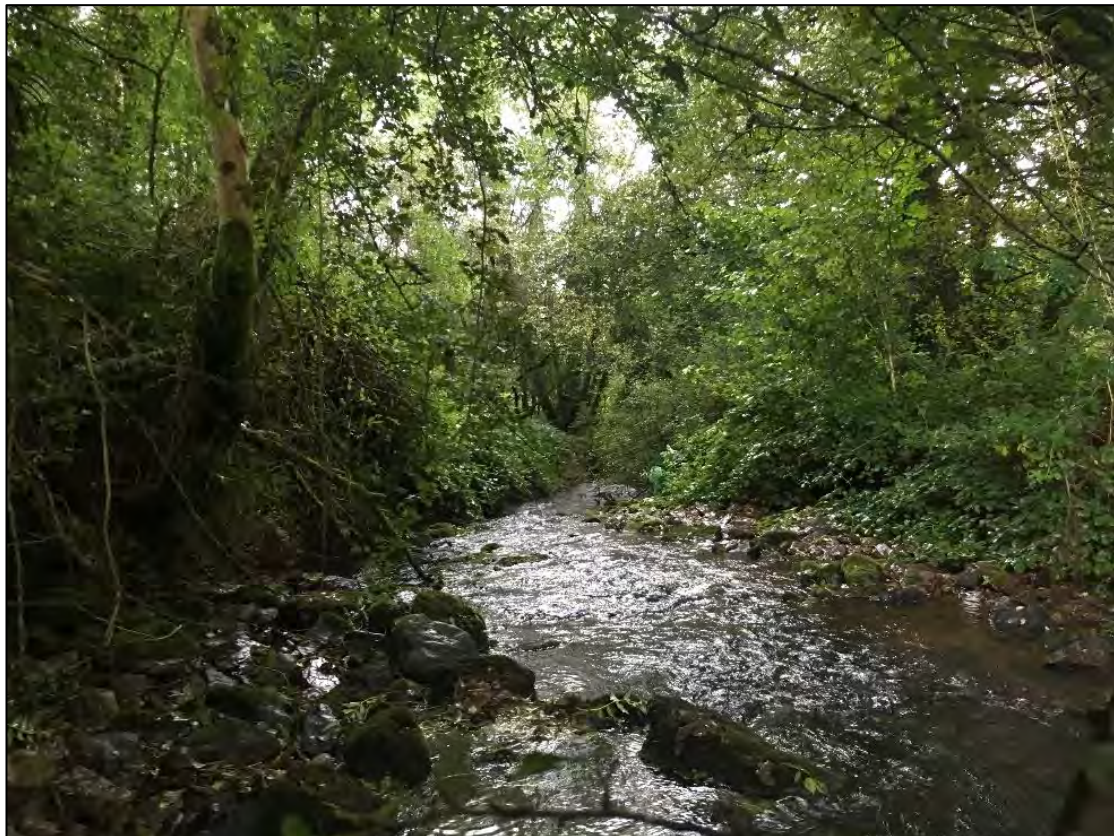
Sample Station 4 is located downstream of the proposed wind farm site to the southeast (grid ref: X 06111 83757). Trees species recorded included Ash (*Fraxinus excelsior*) and Beech (*Fagus sylvatica*). Bankside vegetation included Bramble (*Rubus fruticosus* agg.), willows (*Salix* spp.), nettles (*Urtica dioica*), blackthorn (*Prunus spinosa*), and hawthorn (*Crataegus monogyna*). The river was fast flowing with no turbidity. The substrate comprised boulder, cobble and gravel. Instream vegetation recorded included mosses. Upstream land use consisted of pasture and woodland.

The Q rating assigned to the channel was Q3. It was assigned this value as Group A invertebrates were absent, Group B was scarce, Group C invertebrates were numerous, and Groups D and E were absent.

Plate 2-4 Sample Station 4 (grid ref: X 06111 83757) - Q3
